2020 Lacamas Shores Biofilter Status Report

by Marie Tabata-Callerame and Rodger Hauge

Purpose

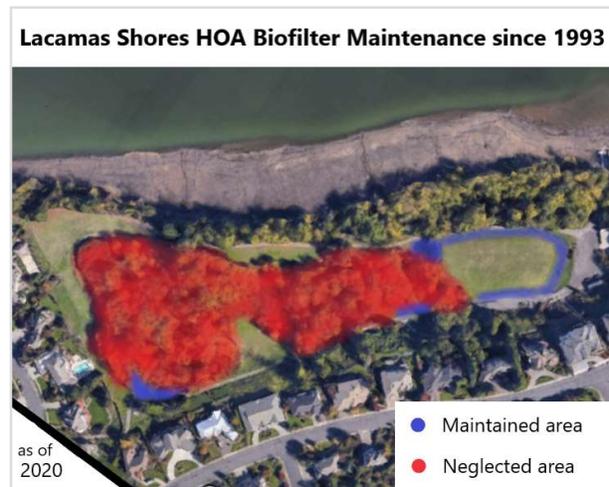
Figure 2. The "Filter" of the Biofilter Remains Un-maintained

The City's December 2019 test and the 2018 chemical oxygen demand ("COD") sample results indicated that there may be a problem with the Biofilter's efficiency¹⁶. However, the 5.62-acres of the filtering biology and sediments of the Biofilter have not been maintained or modified since inception. The reason was the understanding explained in a letter written in 2018 by Ecology stating that "In this case, Ecology is unlikely to approve the CUP Permit" to allow vegetation removal other than invasive species.¹⁷ The City's response to that letter was, as before, to disallow all maintenance that might require tree removal. While the City has required the LSHOA to complete some maintenance to pipes and the adjacent biofiltration system,¹⁸ there are no plans to require maintenance to the largest part of the Biofilter - the filtering plant biology and sediments (Fig. 2¹⁹). While there are plans to work with Clark County and the State to address Lacamas Lake's toxic algae problem,²⁰ there are currently no commitments to test/monitor any other Lake inlets nor the effectiveness of any biofilters in treating stormwater.

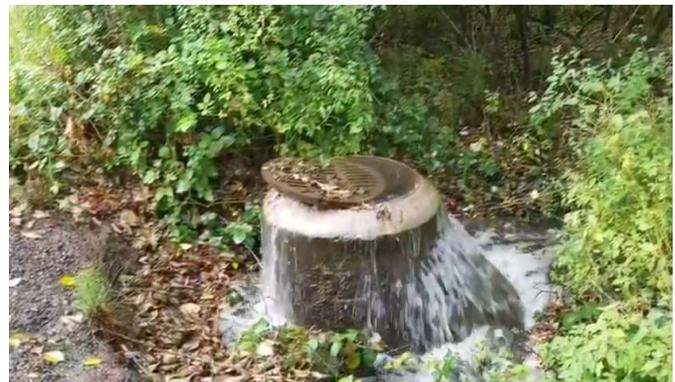
Figure 4. B2 Inlet manhole cover after 20 min. of rain

1. Inlet B2 was [overflowing](#) on the day/time it was sampled (Fig. 4). The water was flowing vigorously out the top of the manhole and flowing down a channel through the Biofilter towards the Lake.²² No measure of flow was made.
2. Inlet B1 was also overflowing but with less volume than B2. There was evidence that there had been excavation around B1.²³
3. The volume of the stream at S4 was much smaller than any other inlet or outlet tested.
4. The separate sediment settling pond system (“swale/pond system”) was functioning. The swale has stormwater running through it and was flowing into the swale/pond system as designed ([Appendix E](#)). The swale vegetation was short and well maintained. The pond was discharging through two black outlets into the shoreline wetlands upstream of the L2 location.

²² It was noted two weeks later, after a rain, that stormwater was seen flowing from the bottom of the B2 manhole riser down a channel into the Biofilter.

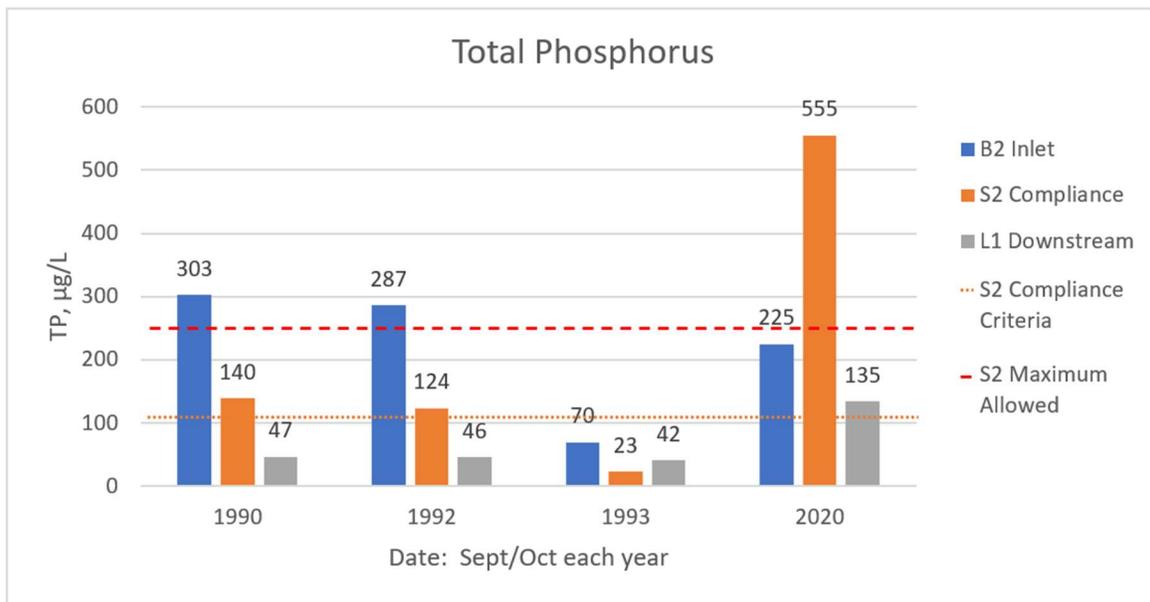
Figure 5. Comparative Stormwater TP Concentrations: 1990s vs. Current for Inlet, Compliance Outlet, and Lake Outlet

Fig. 5 shows the comparison between the Current dataset, where TP elevates significantly after traveling through the Biofilter, and the 1990's datasets, where TP drops, even when the stormwater is already relatively "clean". Note that the Current TP level is typical at the inlet compared to the inlets of the 1990's, i.e., the TP concentration is not higher now than it was recorded in the past. The Biofilter did not lower the same TP concentration in the Current stormwater that it had treated in the 1990's.

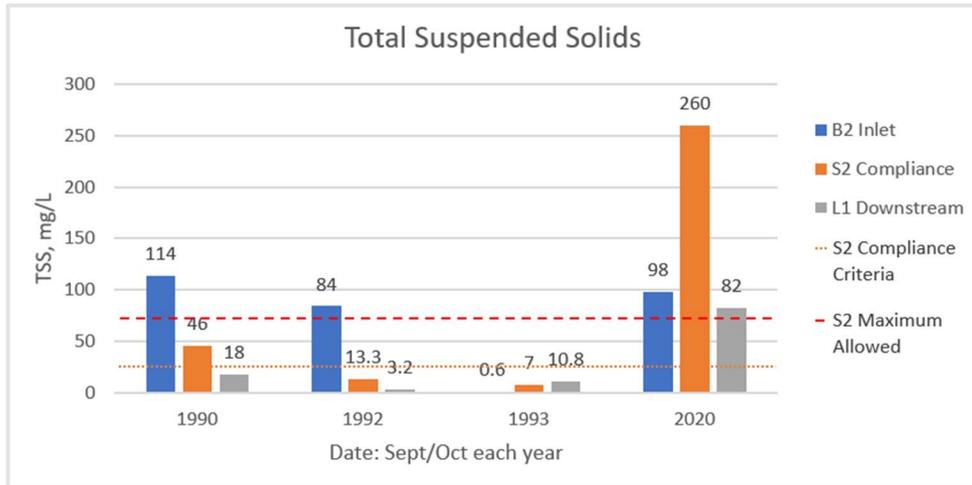
Figure 6. Comparative Stormwater TSS Concentrations: 1990s vs. Current for Inlet, Compliance Outlet, and Lake Outlet

The results for TSS are similar (Fig. 6).

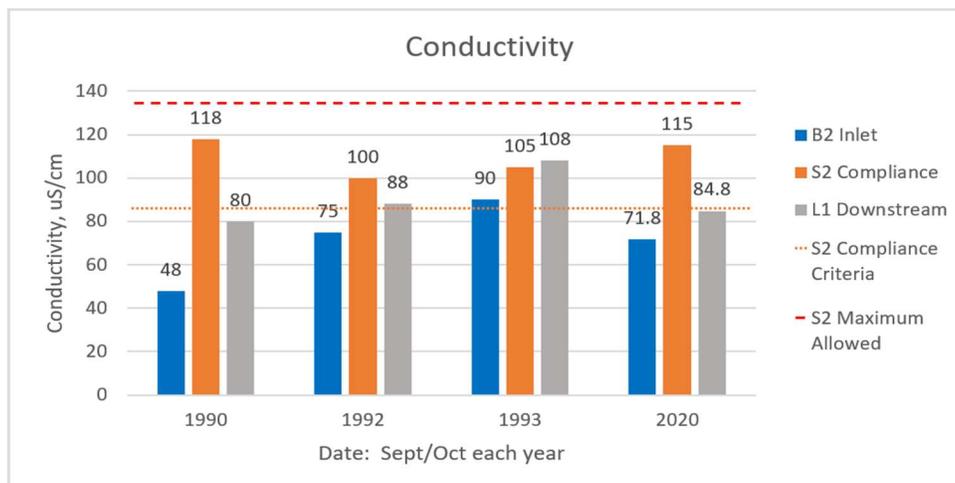
Figure 7. Comparative Stormwater Conductivity Concentrations: 1990s vs. Current for Inlet, Compliance Outlet, and Lake Outlet

Figure 7 shows that the Biofilter does not appear effective to decrease conductivity, neither now nor in the 1990's. Instead, it increases conductivity in the stormwater. Conductivity only decreases for each dataset between the S and L locations, perhaps due to dilution.
