2020 Lacamas Shores Biofilter Status Report

by Marie Tabata-Callerame and Rodger Hauge

Purpose

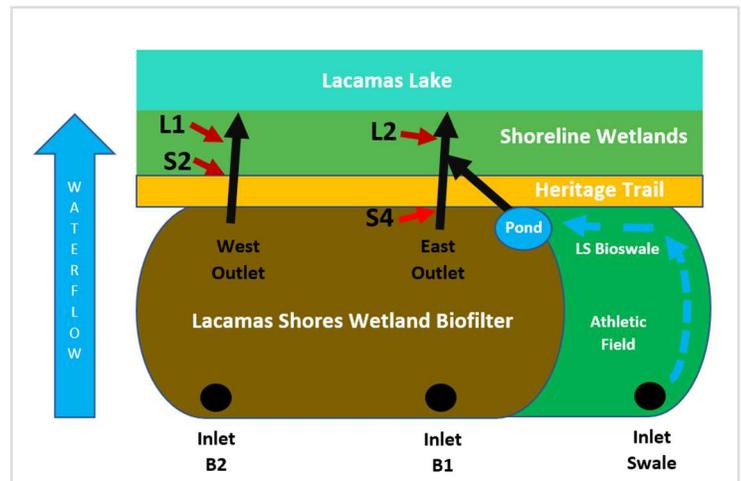
Figure 3. Diagram of Biofilter Waterflow

1. Inlet B2 was [overflowing](#) on the day/time it was sampled (Fig. 4). The water was flowing vigorously out the top of the manhole and flowing down a channel through the Biofilter towards the Lake.²² No measure of flow was made.
2. Inlet B1 was also overflowing but with less volume than B2. There was evidence that there had been excavation around B1.²³
3. The volume of the stream at S4 was much smaller than any other inlet or outlet tested.
4. The separate sediment settling pond system (“swale/pond system”) was functioning. The swale has stormwater running through it and was flowing into the swale/pond system as designed ([Appendix E](#)). The swale vegetation was short and well maintained. The pond was discharging through two black outlets into the shoreline wetlands upstream of the L2 location.
